## SERVICE BULLETIN MAINTENANCE OF WAY EQUIPMENT

**DATE:** 10-5-2010 **BULLETIN NO:** 10-010

**TITLE:** CRUSHED JUPITER NETWORK CABLE

**PRODUCT SERIES / MODEL:** 6700S Tampers

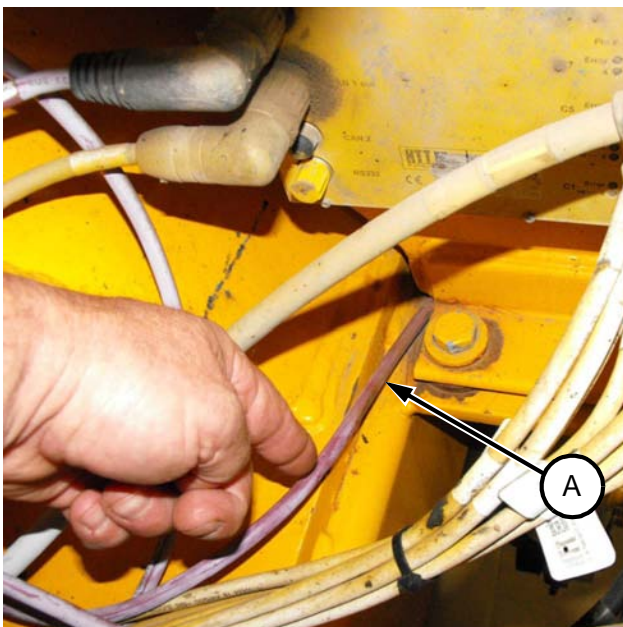
FIGURE 1  
NETWORK CABLE SUSPECTED

1. The Jupiter network cable (A) that needs to be inspected is NET08-09 which is the purple cable going from CAN08 mounted on the engine shroud to CAN09 mounted on the fuel tank. This cable runs between the fuel tank and the frame of the machine.

2. It is possible that this cable can slip down between the fuel tank and the frame and get pinched. With the action of the fuel tank while the machine is working, the cable can be crushed. If this crushing is severe, it could cause conductors inside the cable to short together and cause Jupiter network issues.

3. Disconnect the cable from CAN09 and pull it out for inspection. If there is evidence of crushing anywhere along the cable, it should be replaced.
4. When re-installing the existing (A) or new cable (5), route and secure the cable using the two cable clips (1), screws (2), lock washers (3) and flat washers (4) as shown, to prevent the cable from sliding down between the fuel tank and frame. It will be necessary to drill two pilot holes in the machine frame to install the two #10 mounting screws (2).
