Harsco Track Technologies

SERVICE BULLETIN MAINTENANCE OF WAY EQUIPMENT

DATE: 1-3-2003 **BULLETIN NO:** 02-036

TITLE: 200457 STEERING STOP GROUP

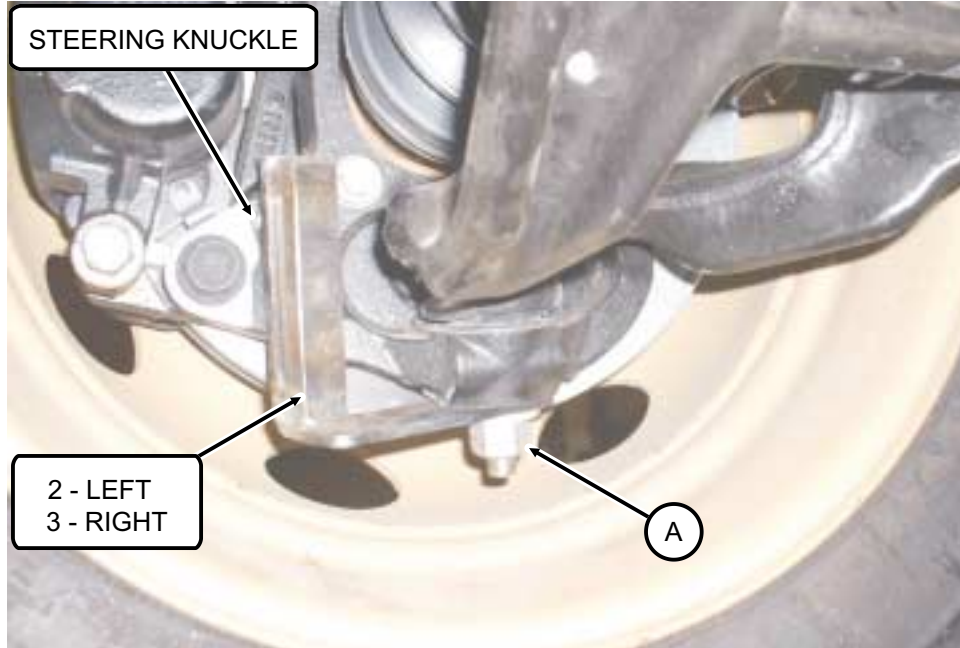
FIGURE 1
STEERING STOP REPLACEMENT

SUMMARY: Reports have been received that front wheels on a 2001 to present Chevrolet 2500HD vehicles were found to have rubbed on the upper control arms when turning hard left or right, and particularly when bouncing on uneven ground. As a result, the anti-lock brake sensor wires have been cut. Therefore, we recommend to inspect the vehicle's front tires, wheels, upper control arms and anti-lock brake sensor wires for damage, wear, nicks, gouges, rubbing, cut or frayed wires, etc.

3. Remove both of the vehicle front wheels.
4. Remove the lower ball joint nut (A) to remove the existing steering stop (not illustrated).
5. Install the new steering stop (2 or 3) over the stud so the tab is facing the rear of the vehicle. Re-install the lower ball joint nut (A), push the steering stop (2 or 3) firmly against the vehicle manufacturer's steering knuckle and torque the nut (A) to 94 ft-lbs.

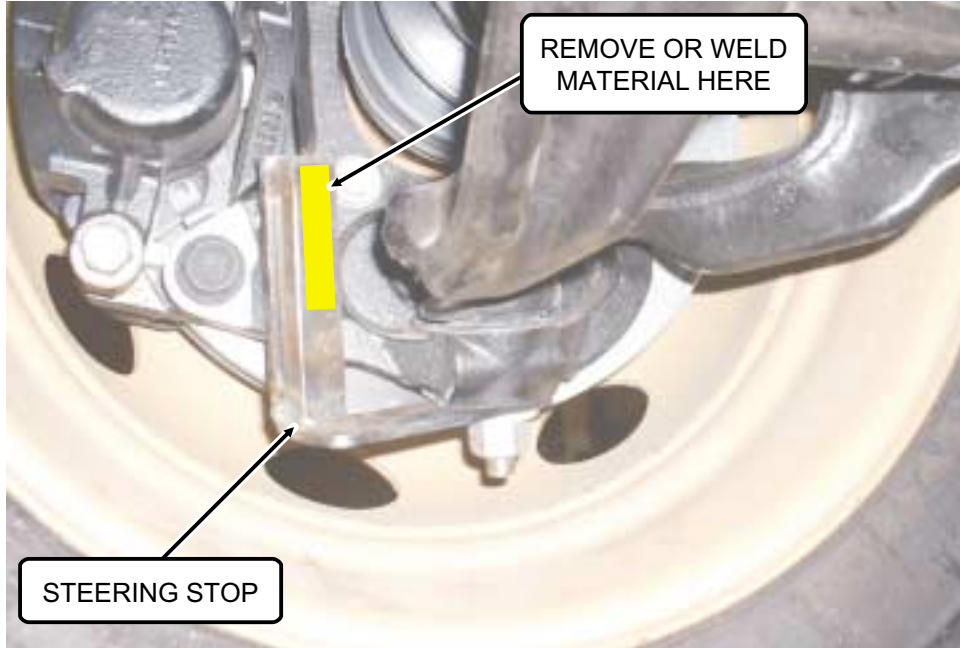
FIGURE 5
STEERING STOP MODIFICATION

17. Lower the front of the vehicle back down to the ground.
18. Turn the vehicle front wheels both hard left and hard right. Check the vehicle's front wheels (tires and rims) for contact with any fixed part of the vehicle in both directions. There must be a minimum of 3/8 - 1/2 inch (9.5 - 12.7 mm) clearance between the vehicle front wheel rim and the vehicle upper control arm.

- 18.1 If there is 3/8 - 1/2 inch (9.5 - 12.7 mm) of clearance, the clearance is correct.
 - 18.2 If there is less than 3/8 - 1/2 inch (9.5 - 12.7 mm) of clearance or any contact at all, the new steering stops must be modified. Go to Step 19 - Steering Stop Modification.

- 18.3 If there is more than 5/8 inch (15.9 mm) of clearance, the steering stops can be modified to decrease the turning radius of the vehicle. Go to Step 19 - Steering Stop Modification.

19. Raise the front of the vehicle high enough so both of the front wheels are off of the ground.
20. Remove both of the vehicle front wheels.
21. If there was more than 5/8 inch (15.9 mm) of clearance, use a grinder to remove material from the steering stop surface in the area shown. DO NOT remove too much material before rechecking the steering stop clearance. Then go back to Step 15 to repeat the Steering Stops Inspection Procedure.

24. If there was less than 3/8 - 1/2 inch (9.5 - 12.7 mm) of clearance or any contact at all, weld a 1 inch wide piece of suitable material to the steering stop surface in the area shown for the thickness needed and length required. Then go back to Step 15 to repeat the Steering Stops Inspection Procedure.
