Harsco Track Technologies

SERVICE BULLETIN MAINTENANCE OF WAY EQUIPMENT

DATE: 4-8-2009 **BULLETIN NO:** 09-005

TITLE: GRINDING HEAD CONTROL

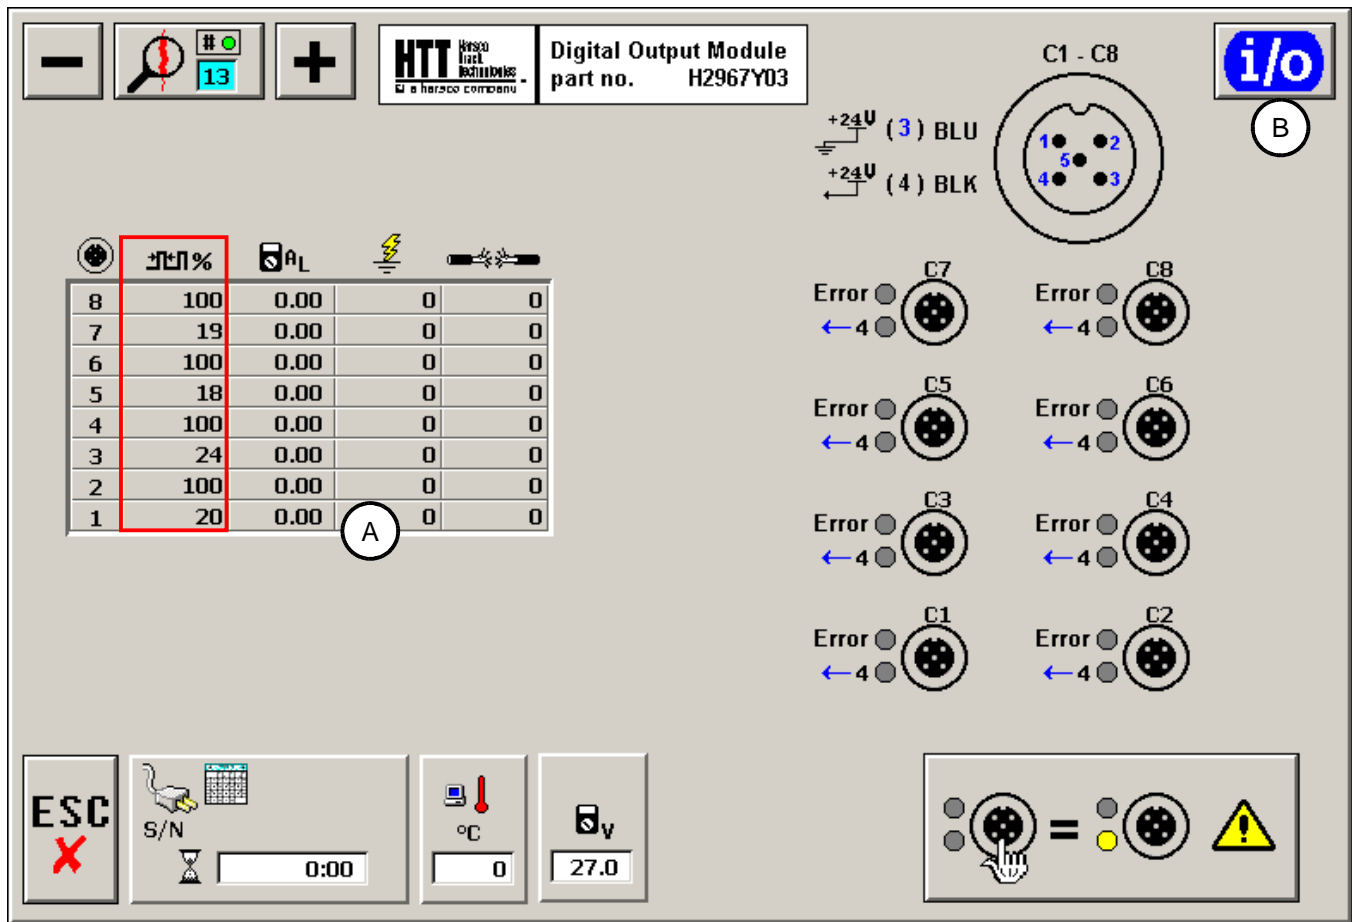
FIGURE 1
DIGITAL OUTPUT MODULE - FEED CYLINDER SOLENOIDS

1. To verify that the feed cylinders are being controlled normally during machine operation, view the applicable Digital Output Module Diagnostic Screens that display the channel information for the Feed Cylinder Solenoids (outlined in red) on the Information Table (A). Use the I/O Button (B) to confirm the function connected to each of the channels.

3. While grinding, watch the PWM values (outlined in red) on the Information Table (A) to determine if the values are adjusting. Do not confuse the "Enable" solenoids with the "Control" solenoids, as the Enable solenoids will always display a 100% value while grinding.

4. Note that it is possible that the grinding head may ramp down its PWM control to its MIN PWM value and stay there if the target power for the pattern is lower than can be achieved. Be sure to monitor all 10 "Control" solenoids per car.

5. Verify the feed cylinders are being controlled normally following the instructions in this Service Bulletin. See Verifying Machine Operation.
 - 5.1 If you should encounter this control issue behavior during the verification process or during actual machine operation, contact the Engineering Controls Department at the HTT, Columbia, SC. facility to verify what software is installed and potentially acquire the relevant update.
